OPPORTUNITIES AND CONSTRAINTS FOR EVANS CREEK

EARLY IMPLEMENTATION ACTIVITIES: UPPER SANTA ANA RIVER HABITAT CONSERVATION PLAN

August 2019

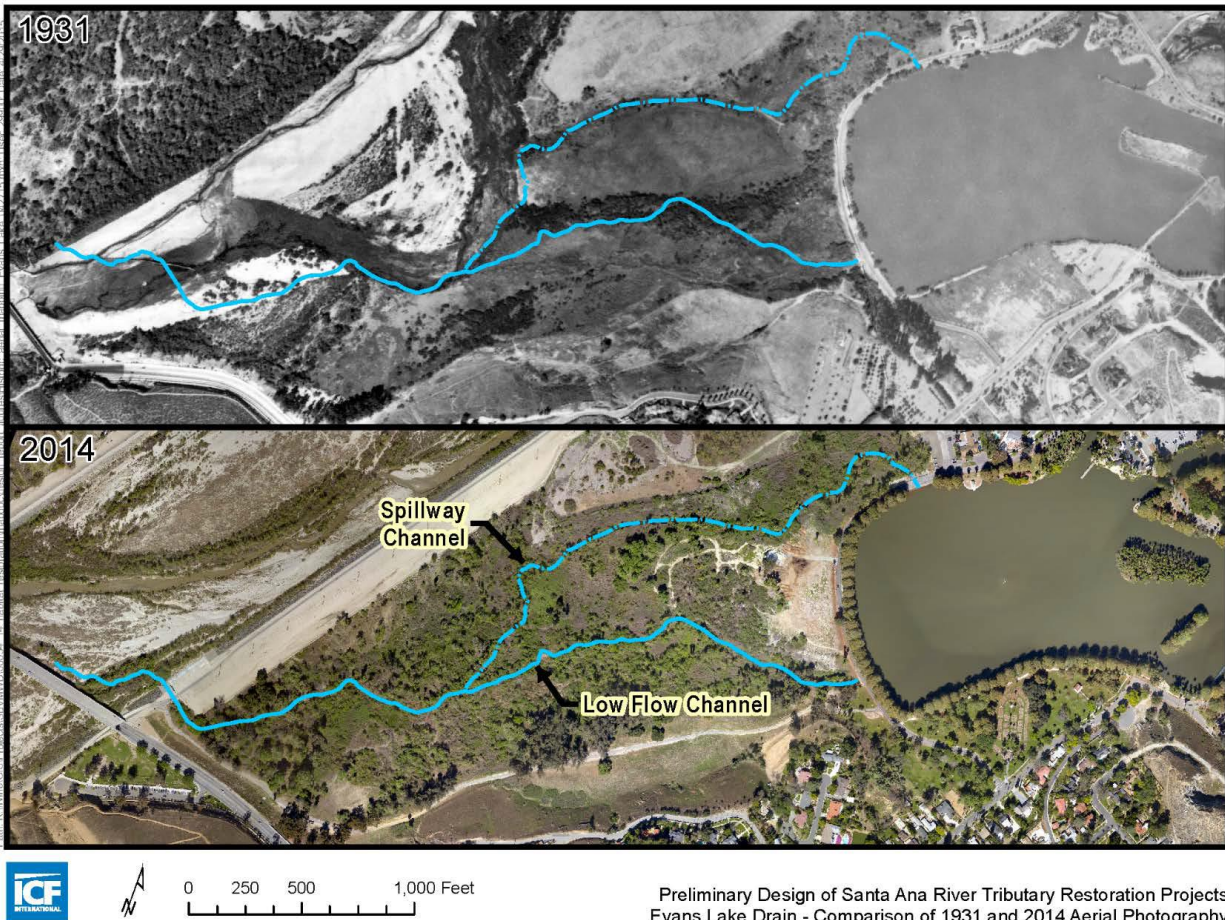
Figure 3. Comparison of 1931 and 2014 Aerial Photography at Lake Evans

Lake Evans in Fairmount Park was constructed in the early 1900s. The footprint of Lake Evans was the same in 1931 as it is today. The greatest differences apparent in the two images are that the Santa Ana River levee did not exist in 1931 and a large meander bend of the Santa Ana River looped into the site to the east side of the present day levee. The downstream end of the present day spillway channel follows the perimeter of the 1931 meander loop, and traces of the meander are

observed in the vegetation patterns in 2014. Nearly the entire lower half of the 2014 low-flow channel is located in an area that used to be occupied by the Santa Ana River channel or its active floodplain in 1931. This explains why the elevation gradient of the 2014 low-flow channel decreases as it approaches the levee. It appears that, in 1931 the drainage from Lake Evans took a more central location than present day, as evident in the riparian corridor in the central portion of the 1931 image. Overall, the vegetation appears less dense in 1931 compared to 2014 conditions. Lake Evans also traps bedload sediment and prevents it from supplying the channel below.

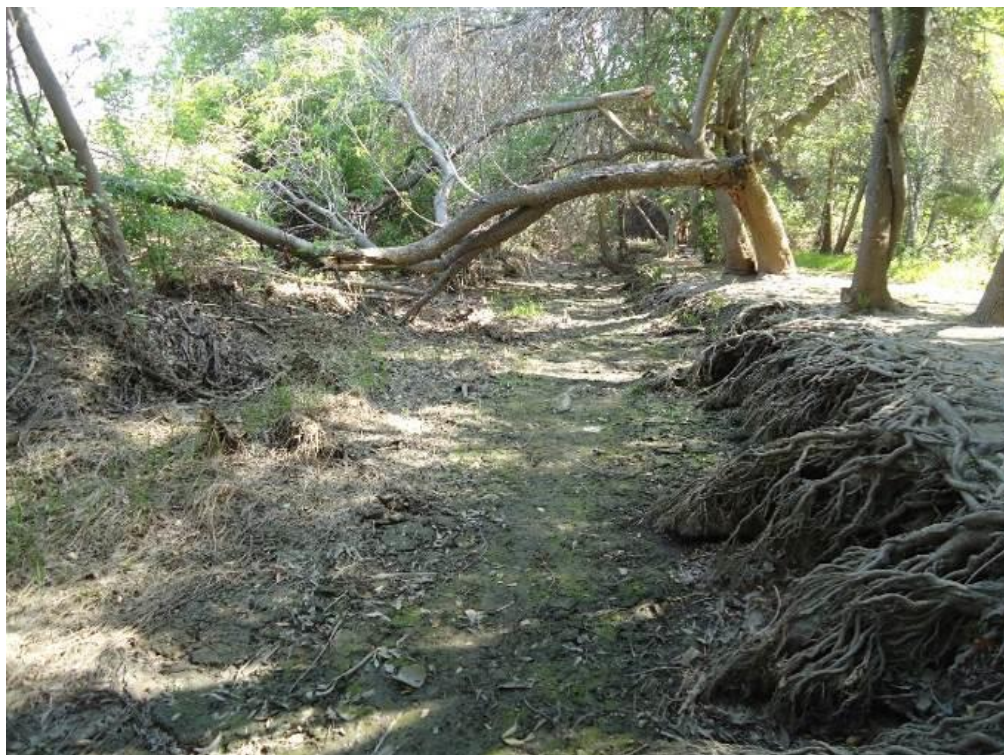
Figure 4. Low-flow channel 400 feet upstream of Santa Ana River. Area is highly disturbed by human visitation (3/14/2014)

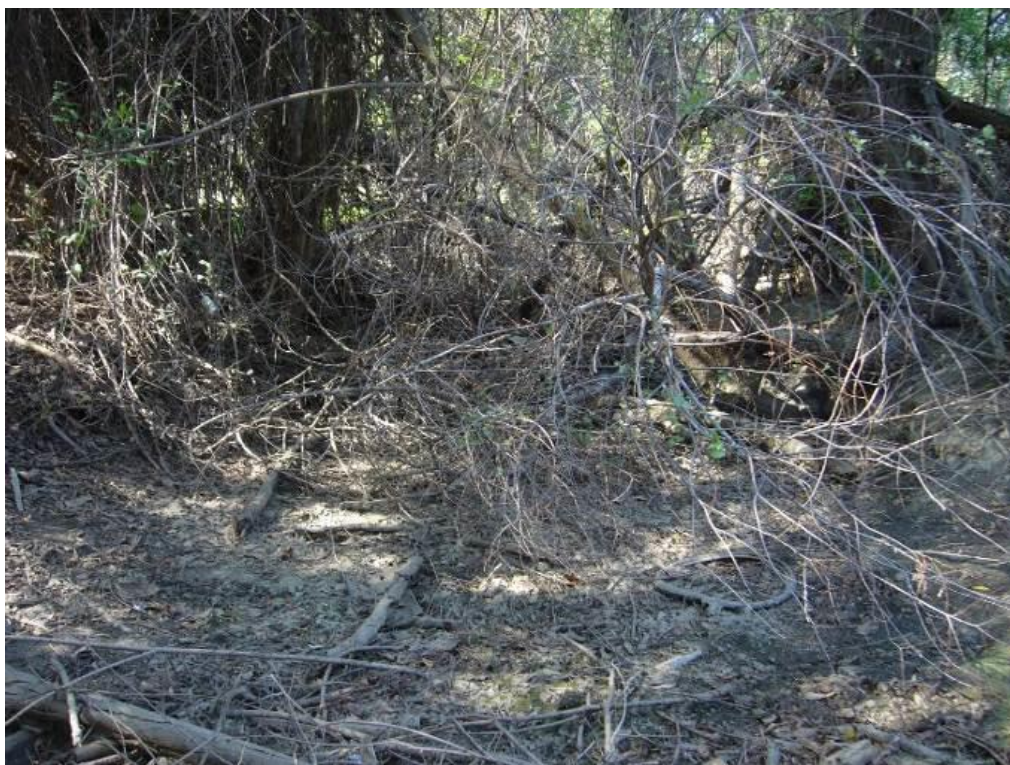
Figure 5. Dense vegetation within channel (3/14/2014)

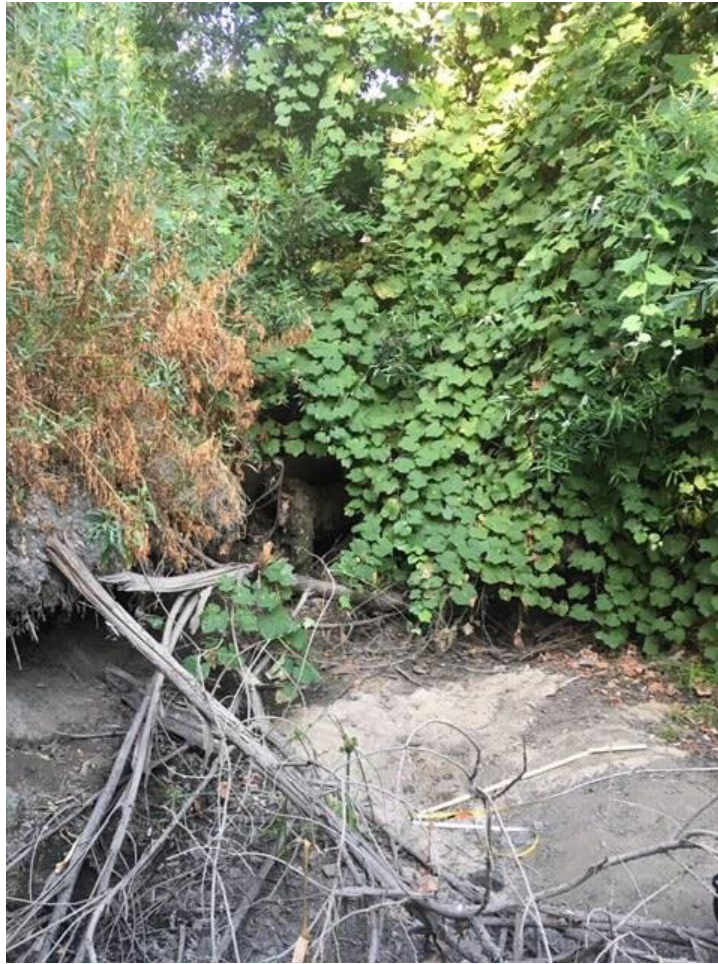
Figure 6. Undercut bank of spillway channel on the left with dense riparian vegetation (8/2/2018)

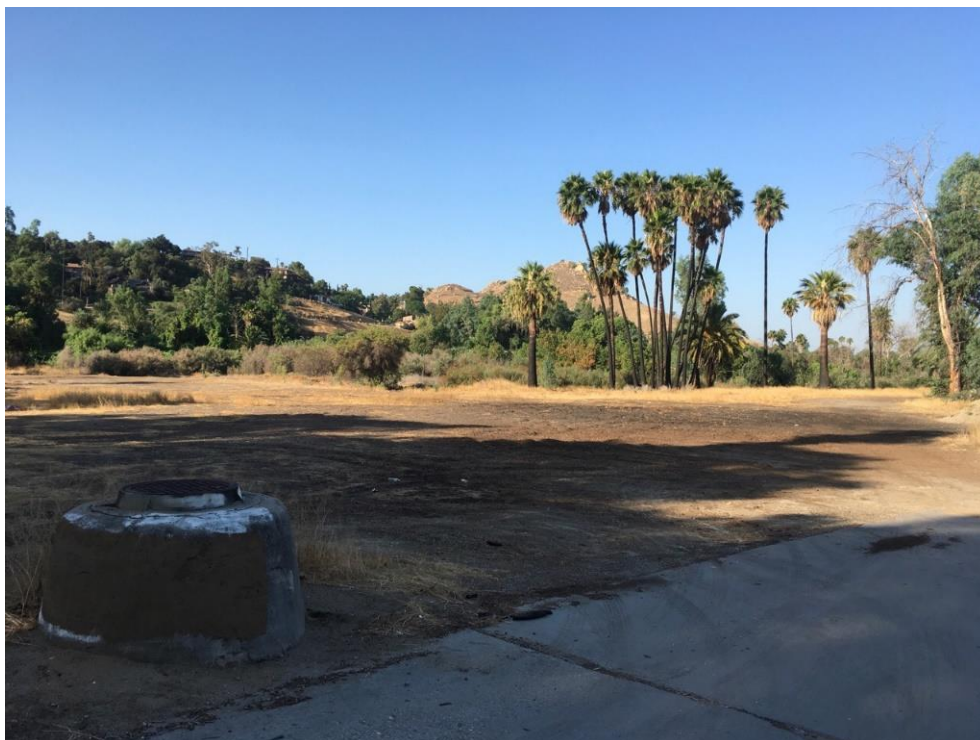
Figure 7. Looking west across site from Dexter Drive with disturbed habitat in the foreground. Remnants of fire can be seen on palm trees (8/2/2018)

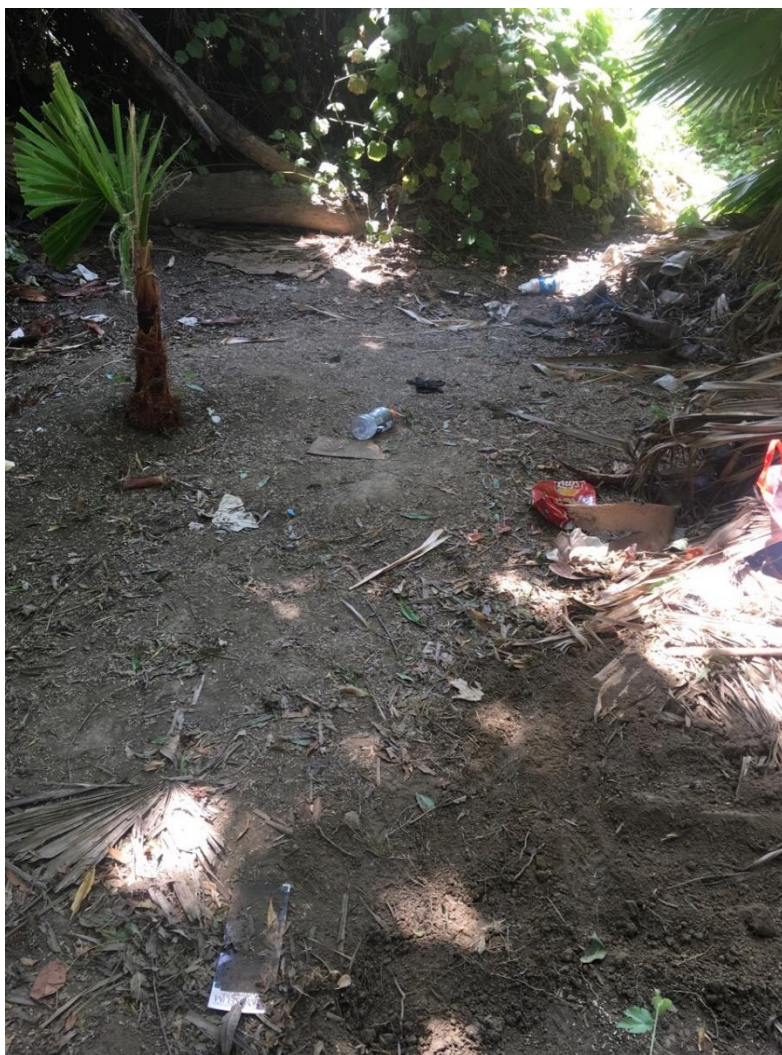
Figure 9. Trash and debris from homeless encampments

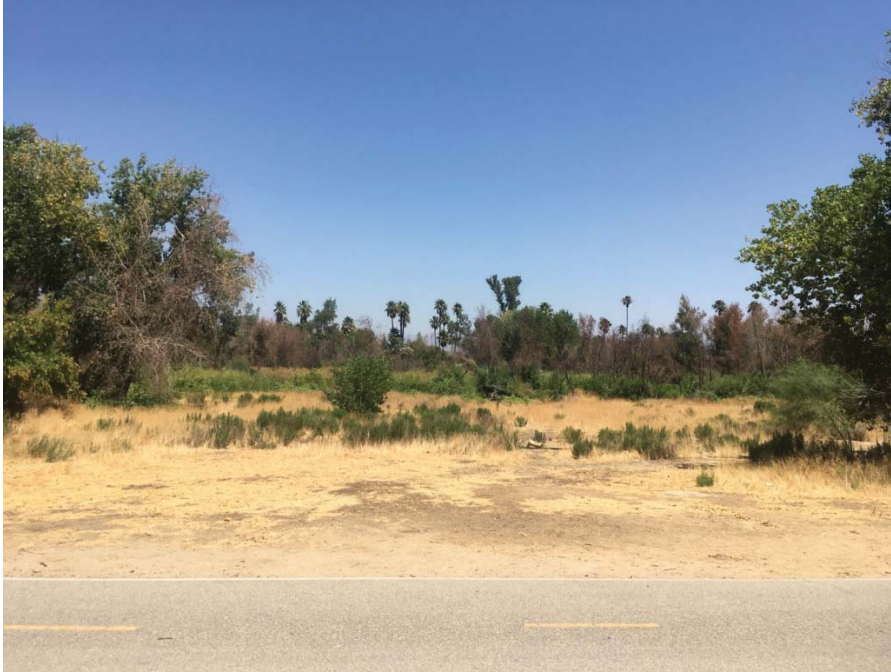
Photo 13

Description:
Disturbed habitat at
south end of project

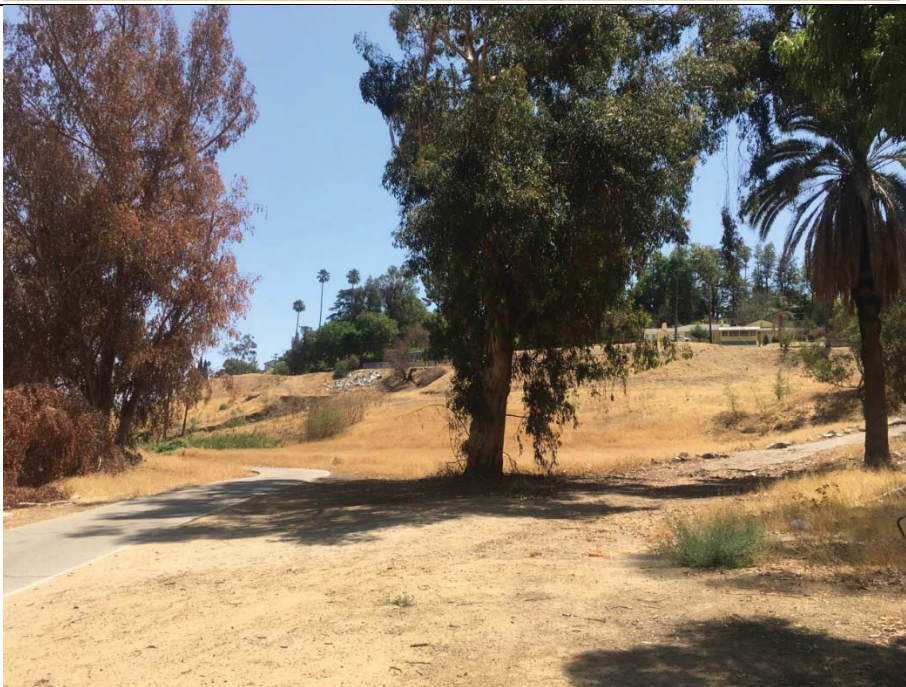
Photo 14

Description:
Disturbed habitat just
south of project site

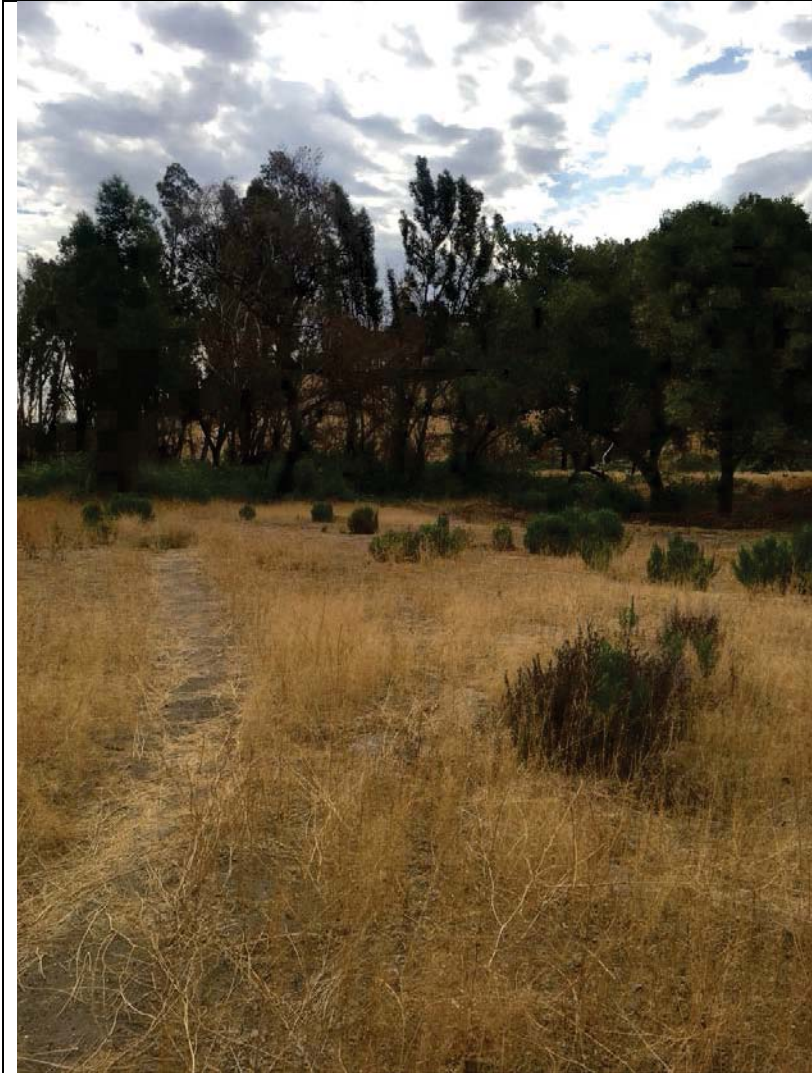
Photo 15

Description:
Disturbed habitat at
south end of project
site

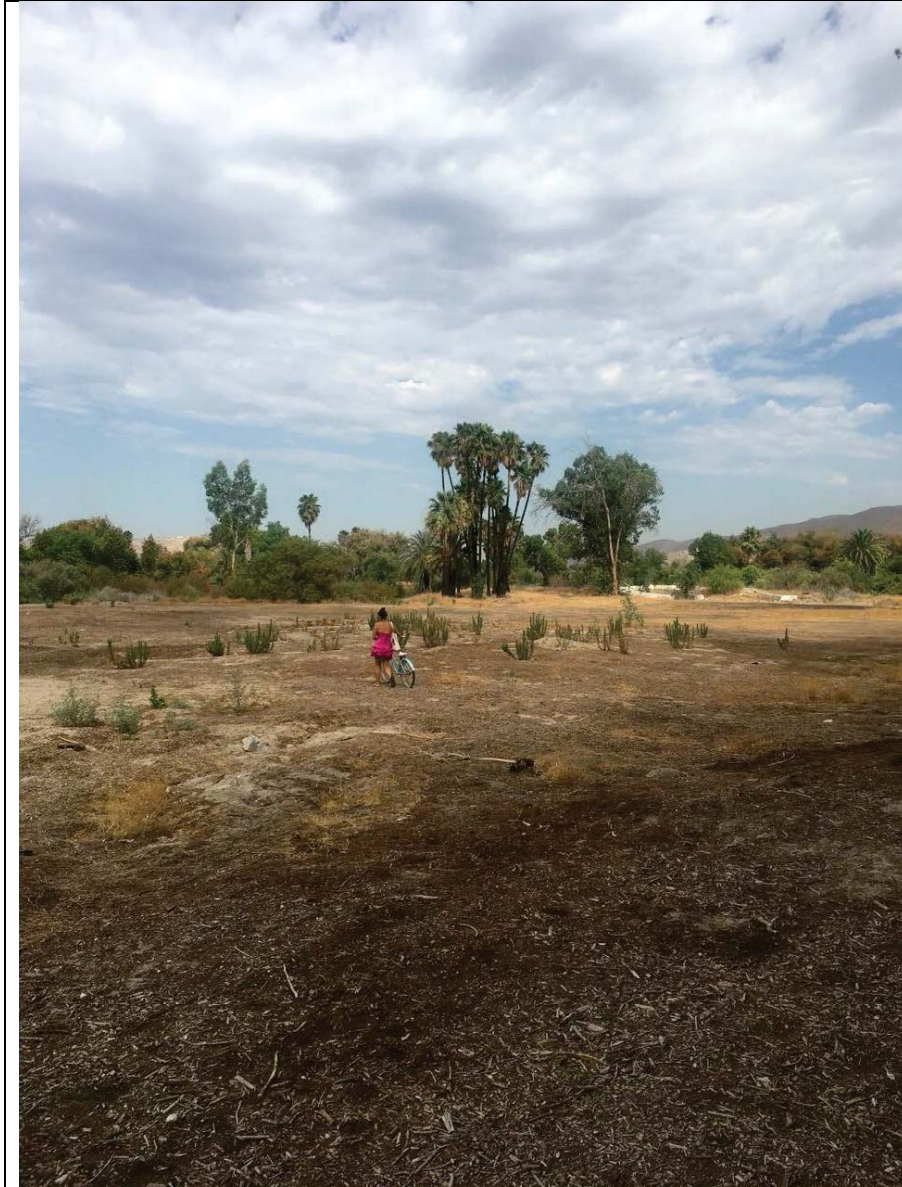
Photo 20

Description:
Disturbed habitat at
east end of site
