Draft Barneby Ridge-cress Habitat Evaluation Memorandum

Uinta Basin Railway

Seven County Infrastructure Coalition

July 30, 2020

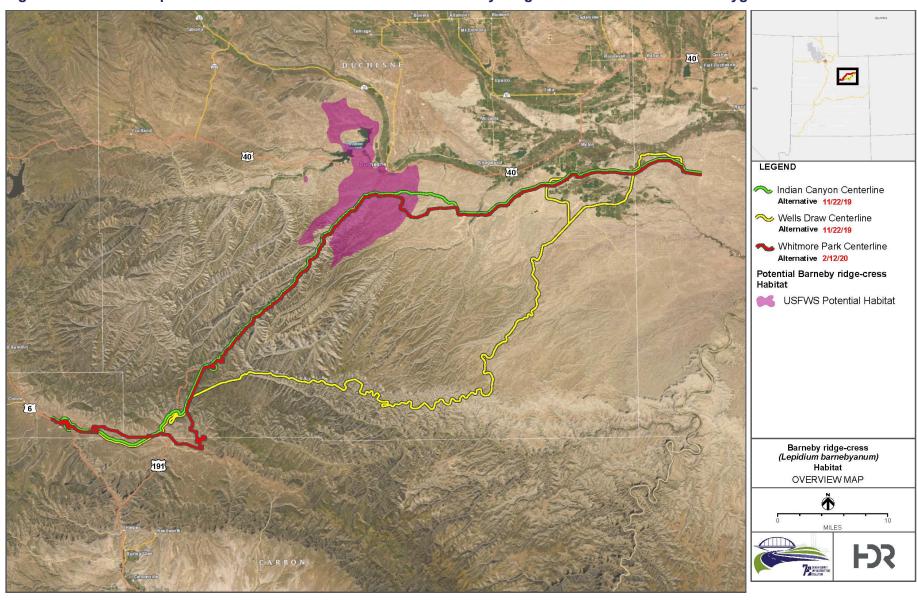
Figure 1. Overview Map of Alternative Routes and the USFWS Barneby Ridge-cress Potential Habitat Polygon

USFWS provided a polygon in geographic information systems (GIS) format that shows potential habitat for Barneby ridge-cress (Moore 2019). To identify suitable habitat in the study areas, HDR used GIS software to confirm where this potential habitat polygon overlap the three alternative study areas. Figure 1 provides an overview map of the three alternatives and the USFWS potential habitat polygon. Once this overlapping area was defined, high-quality aerial images (collected by AeroGraphics from June to October 2019) were used to identify sites that appeared white, thus representing the white limestone shale habitat preferred by Barneby ridge-cress (see Section 2.3, Habitat).

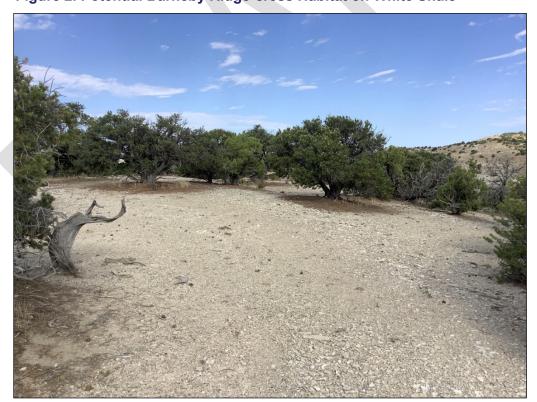
Figure 2. Potential Barneby Ridge-cress Habitat on White Shale

Field evaluations confirmed that areas identified as white on aerial images were also white on the ground and displayed the habitat characteristics described in Section 2.3, Habitat. These white areas were located in pinyon-juniper woodlands and included mound-forming species. Figure 2 provides a photo of one such location. However, HDR biologists also confirmed that areas adjacent to these white sites were also located in pinyon-juniper habitat and also included other mound-forming species, although the mound-forming species occurred at a higher density in the white shale locations.

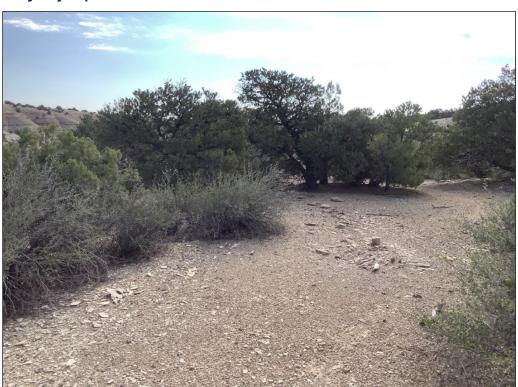
Figure 3. Potential Barneby Ridge-cress Habitat in General Pinyon-juniper Woodland

Figure 3 provides a photo of potential Barneby ridge-cress habitat in a general pinyon-juniper woodland setting. In addition, areas adjacent to the white sites varied in light-brown colors and could be interpreted to resemble weathered concrete. For this reason, potentially suitable habitat is presented in two categories: general pinyon-juniper habitat and white shale habitat.
