OPPORTUNITIES AND CONSTRAINTS FOR EVANS CREEK

EARLY IMPLEMENTATION ACTIVITIES: UPPER SANTA ANA RIVER HABITAT CONSERVATION PLAN

August 2019

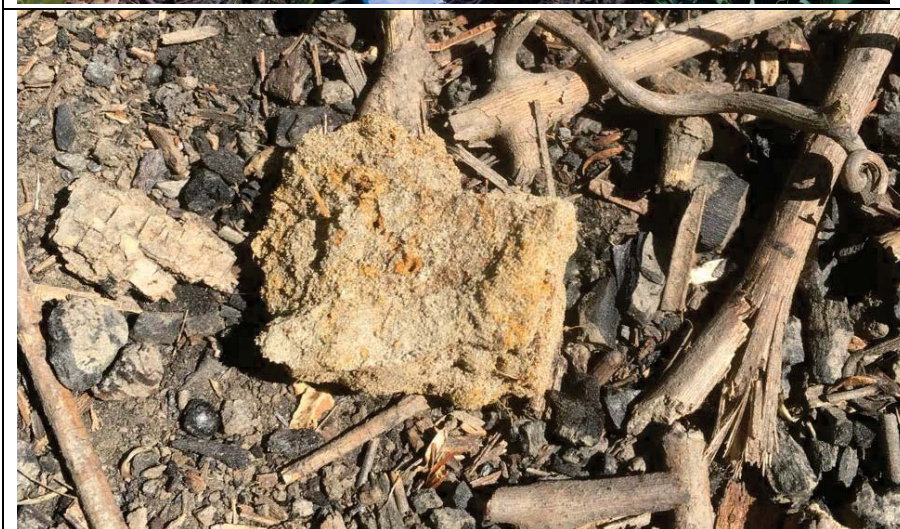
Photo 29

Description:
SP6 showing sandy
redox soils

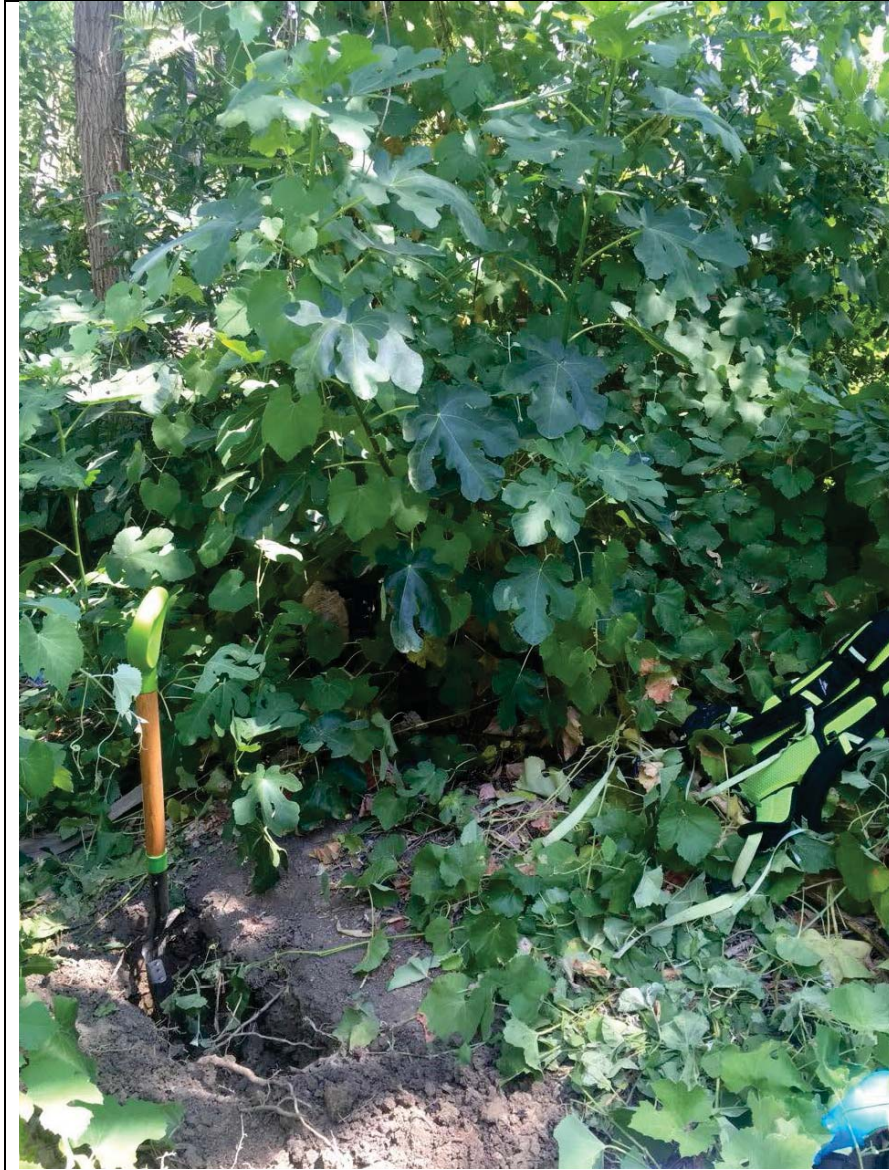
Photo 30

Description:
SP7 in uplands
adjacent to SP6

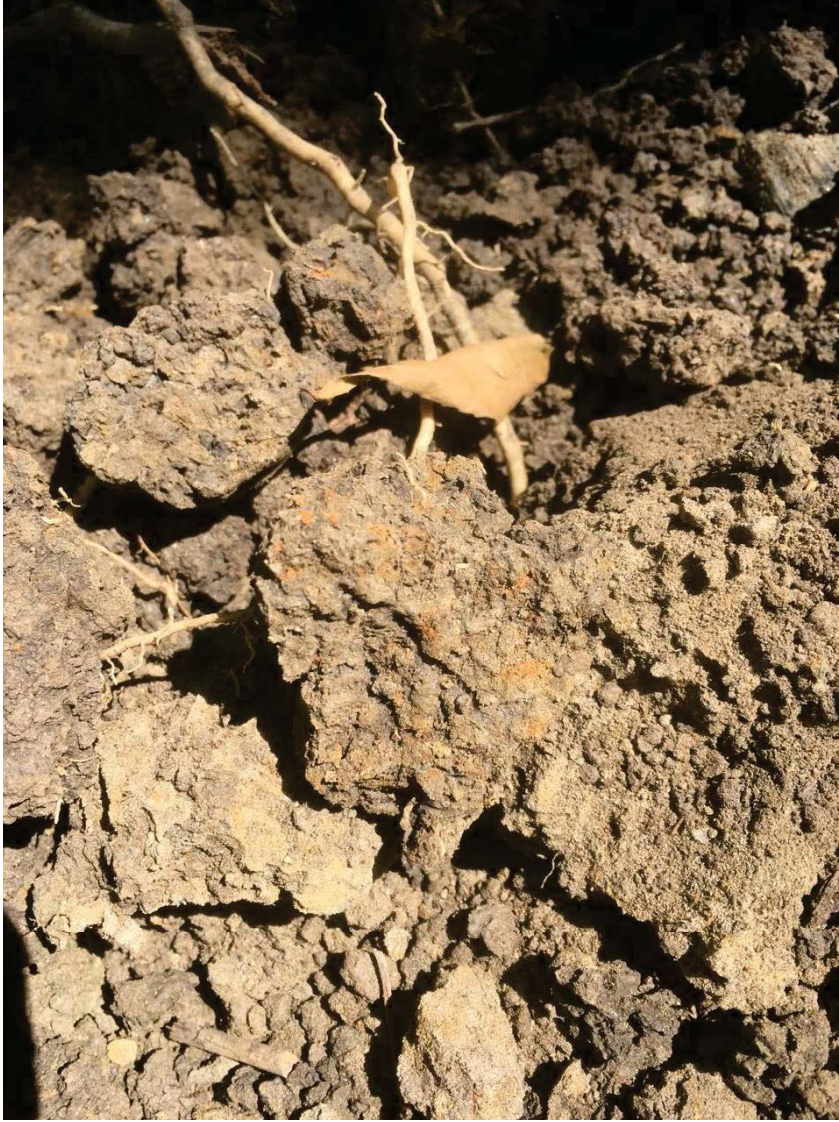
Photo 31

Description:
SP7 in uplands
adjacent to SP6

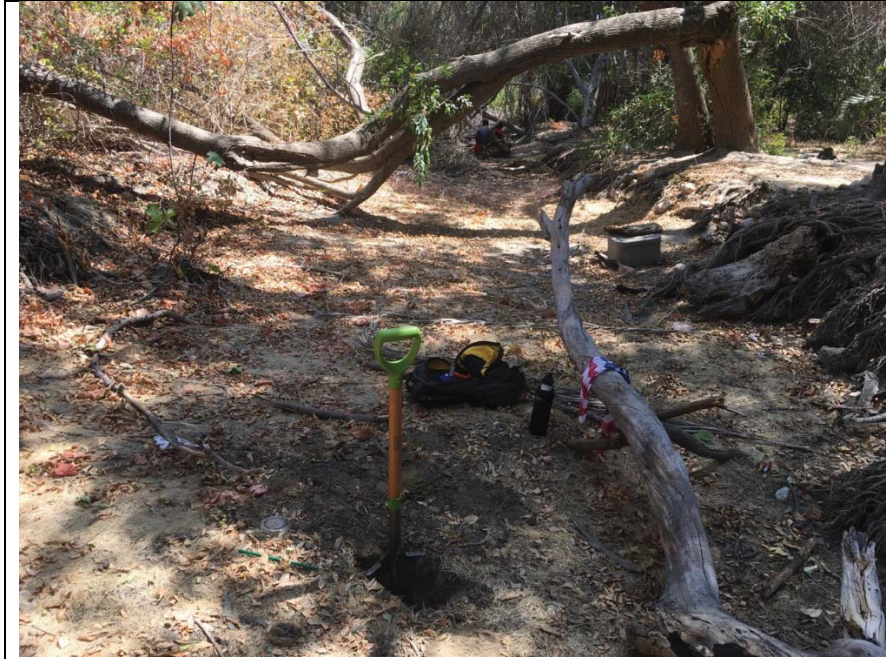
Photo 32

Description:
SP11 in channel

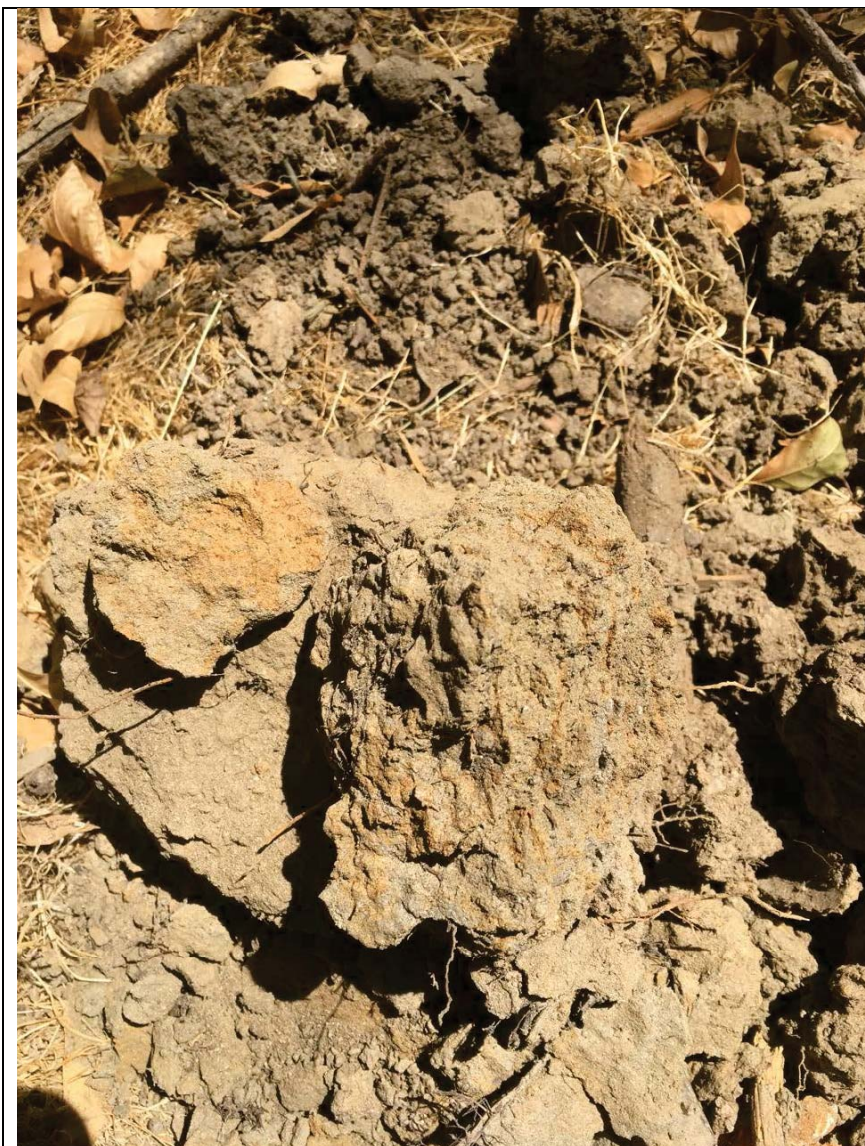
Photo 33

Description:
SP11 showing sandy
redox

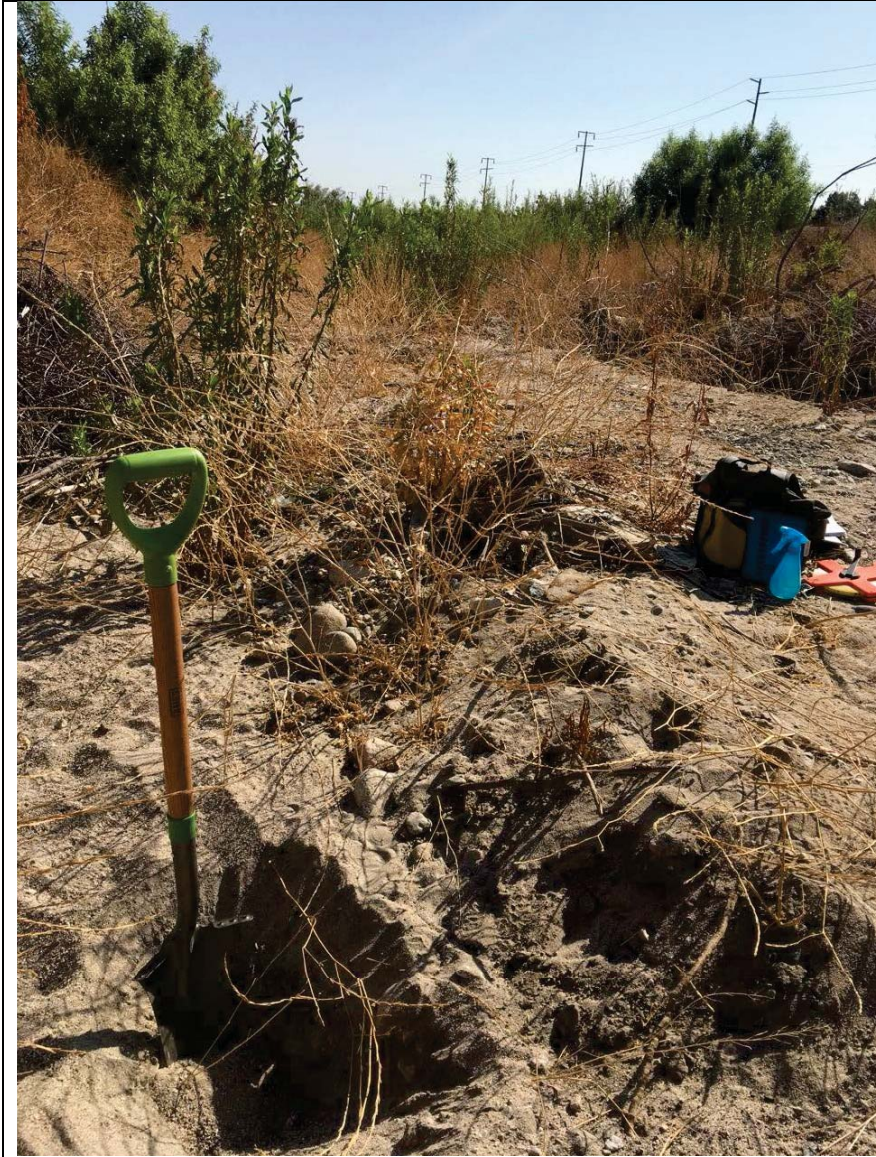
Photo 34

Description:
SP9 within side
channel of Santa Ana
River

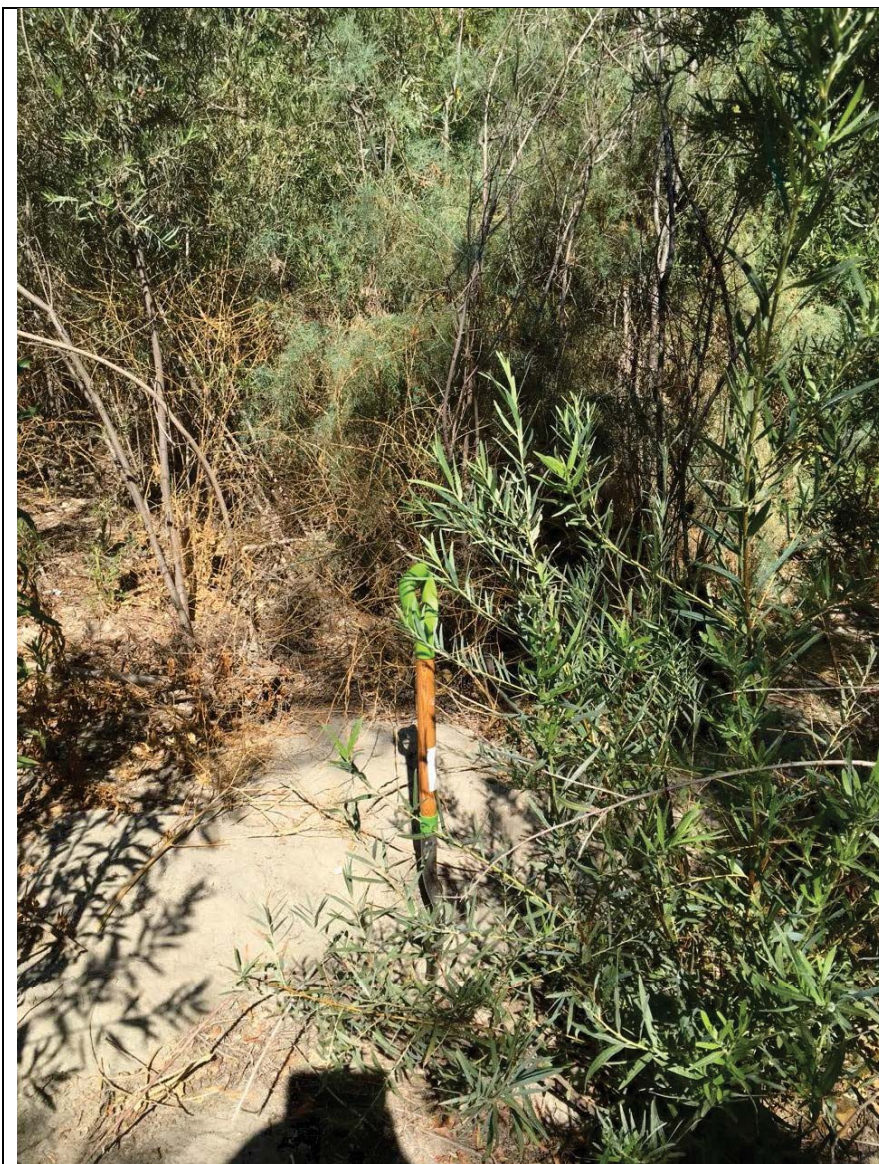
Photo 35

Description:
SP10 adjacent to low
flow of Santa Ava
River

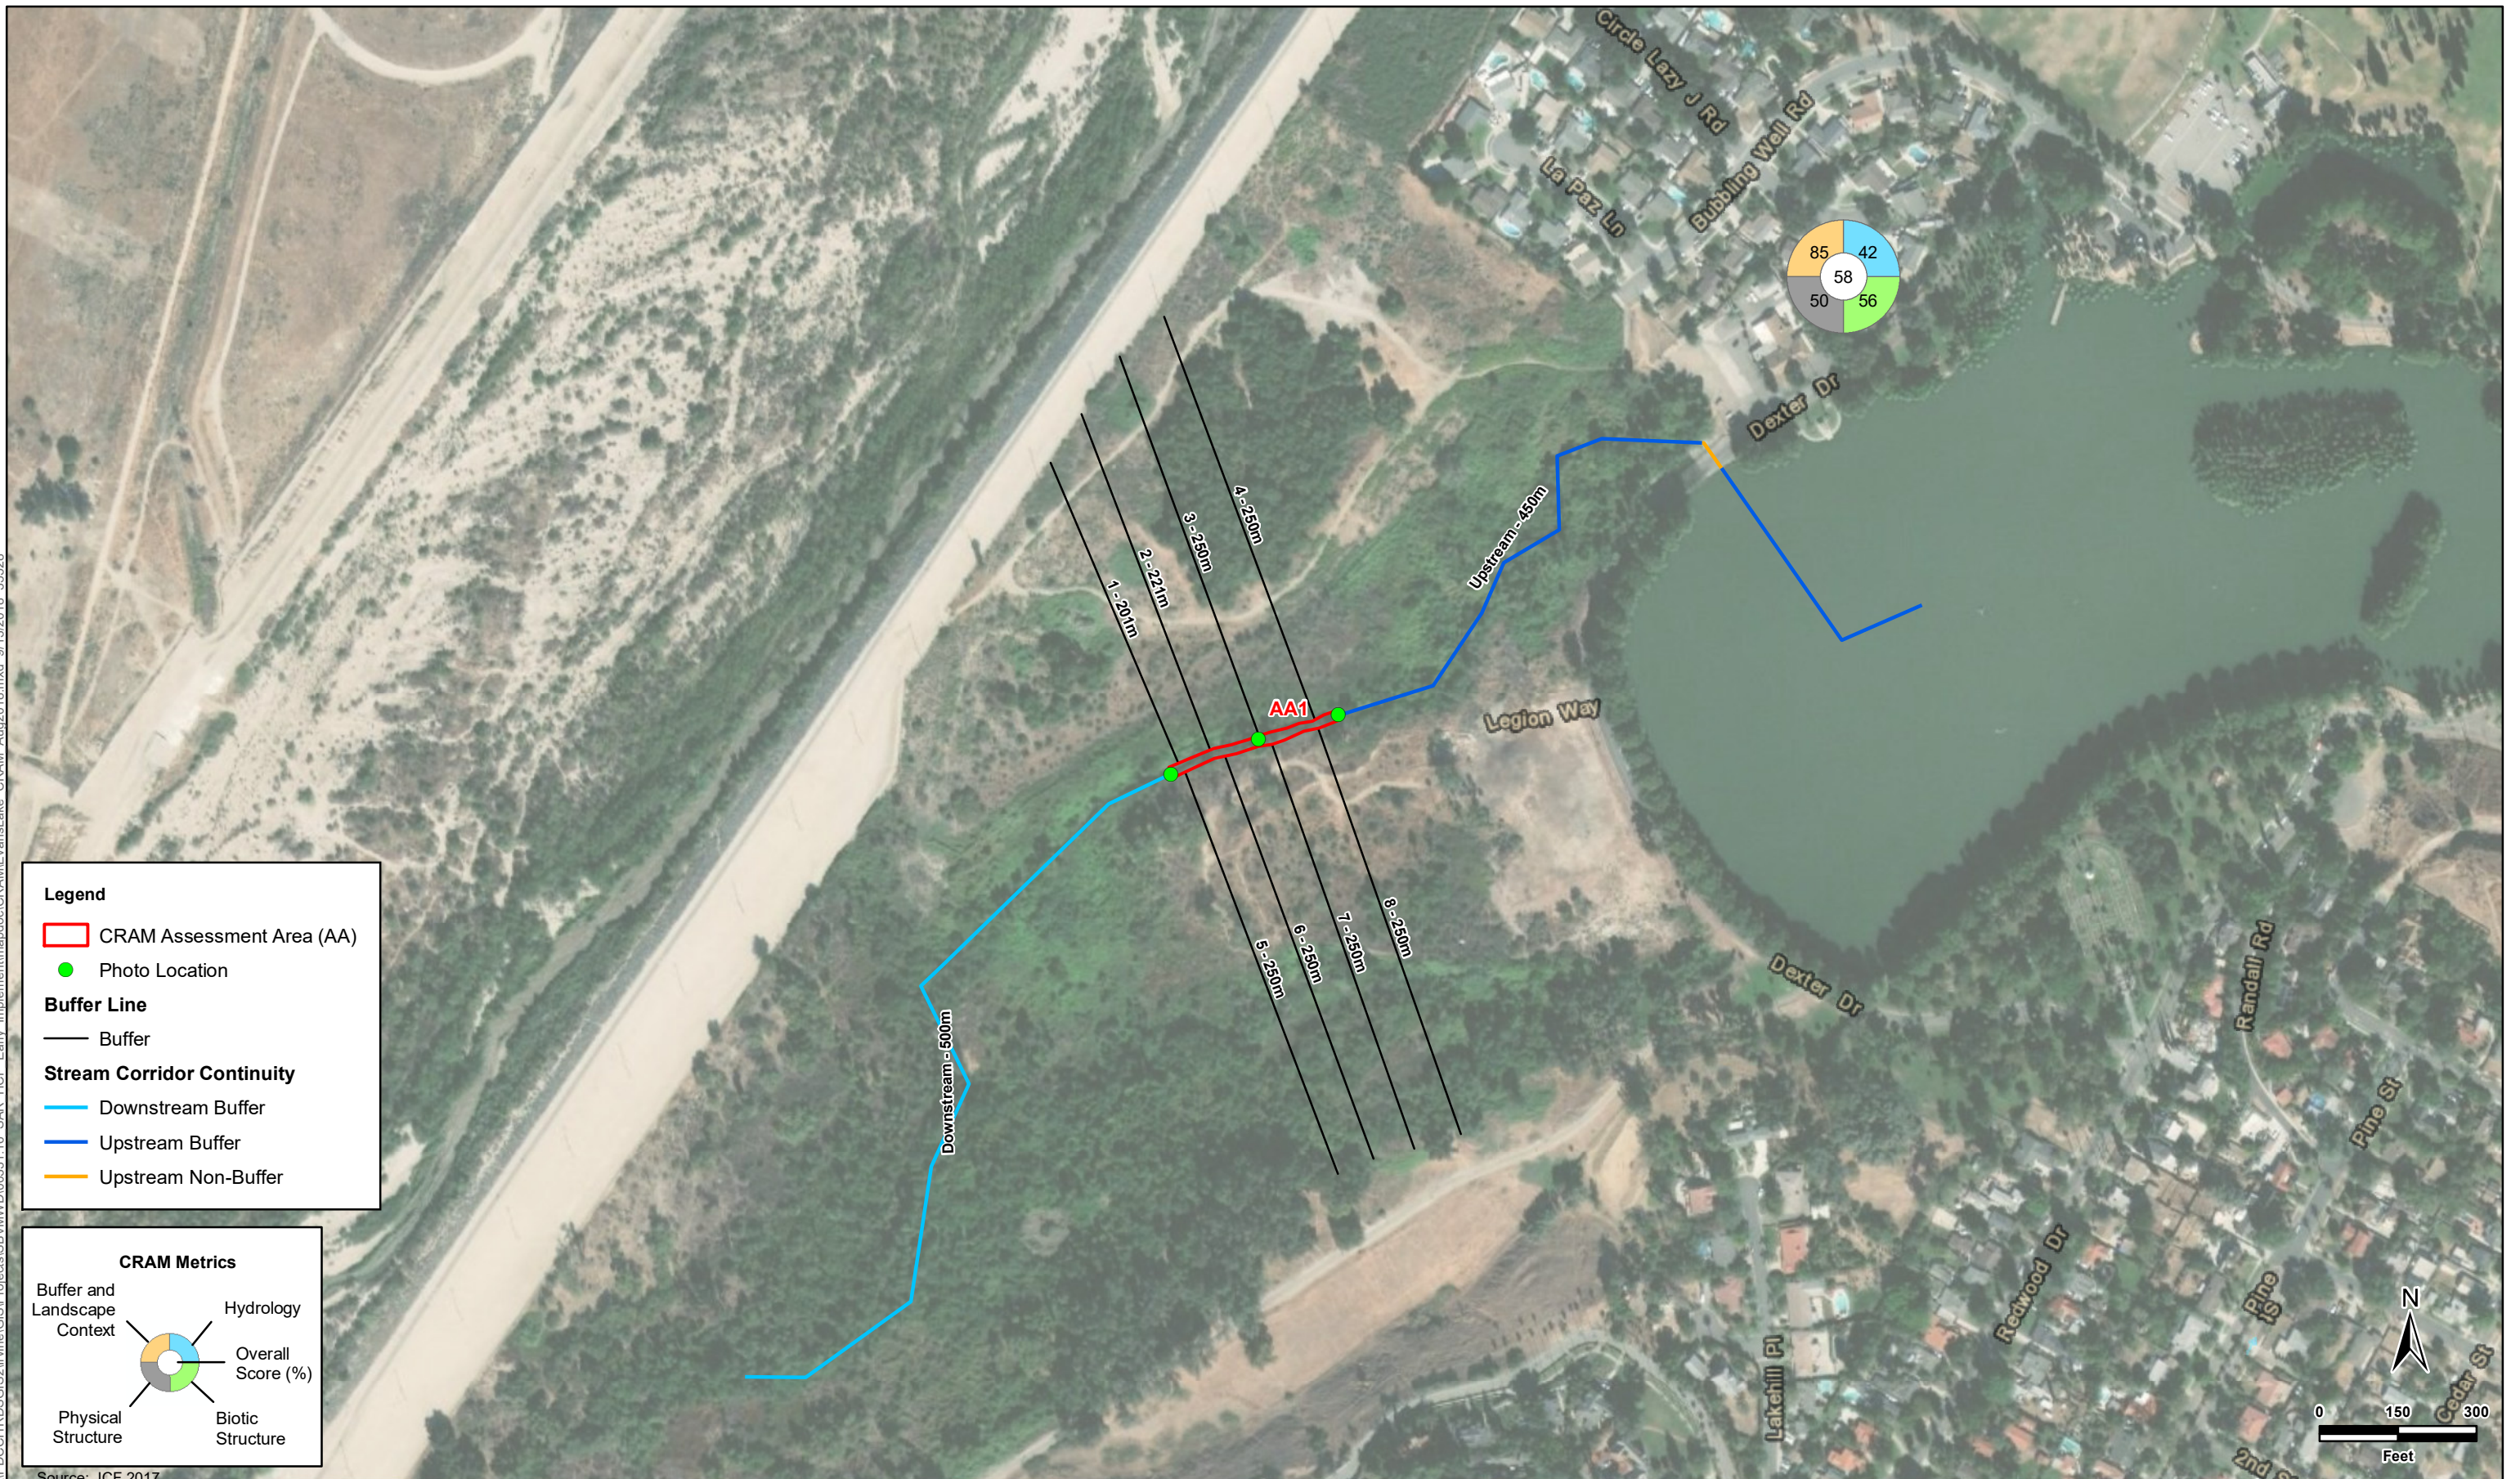
Figure 2-AA1
Evan's Lake CRAM Results
Early Implementation for the Upper Santa Ana River Habitat Conservation Plan

AA1 is located within the northern drainage channel at the project (Figure 2-AA1). The channel receives flows from what appears to be a culvert at the upstream end as well as overflows via a spillway from Evan's Lake. The AA received an overall attribute score of 85% for the Buffer and Landscape Context attribute. The Stream Corridor Continuity metric received an A with 164 feet (50 meters) of non-buffer segment upstream (Dexter Drive) from the AA and no breaks downstream. The submetric Percent of AA with Buffer received an A with 100% of the AA containing buffer. The average buffer width came to 787 feet (240 meters) and thus received an A. The buffer condition submetric received a C due to moderate human impact (homeless encampments) and soil disturbance and mowing of the buffer on the northern side.

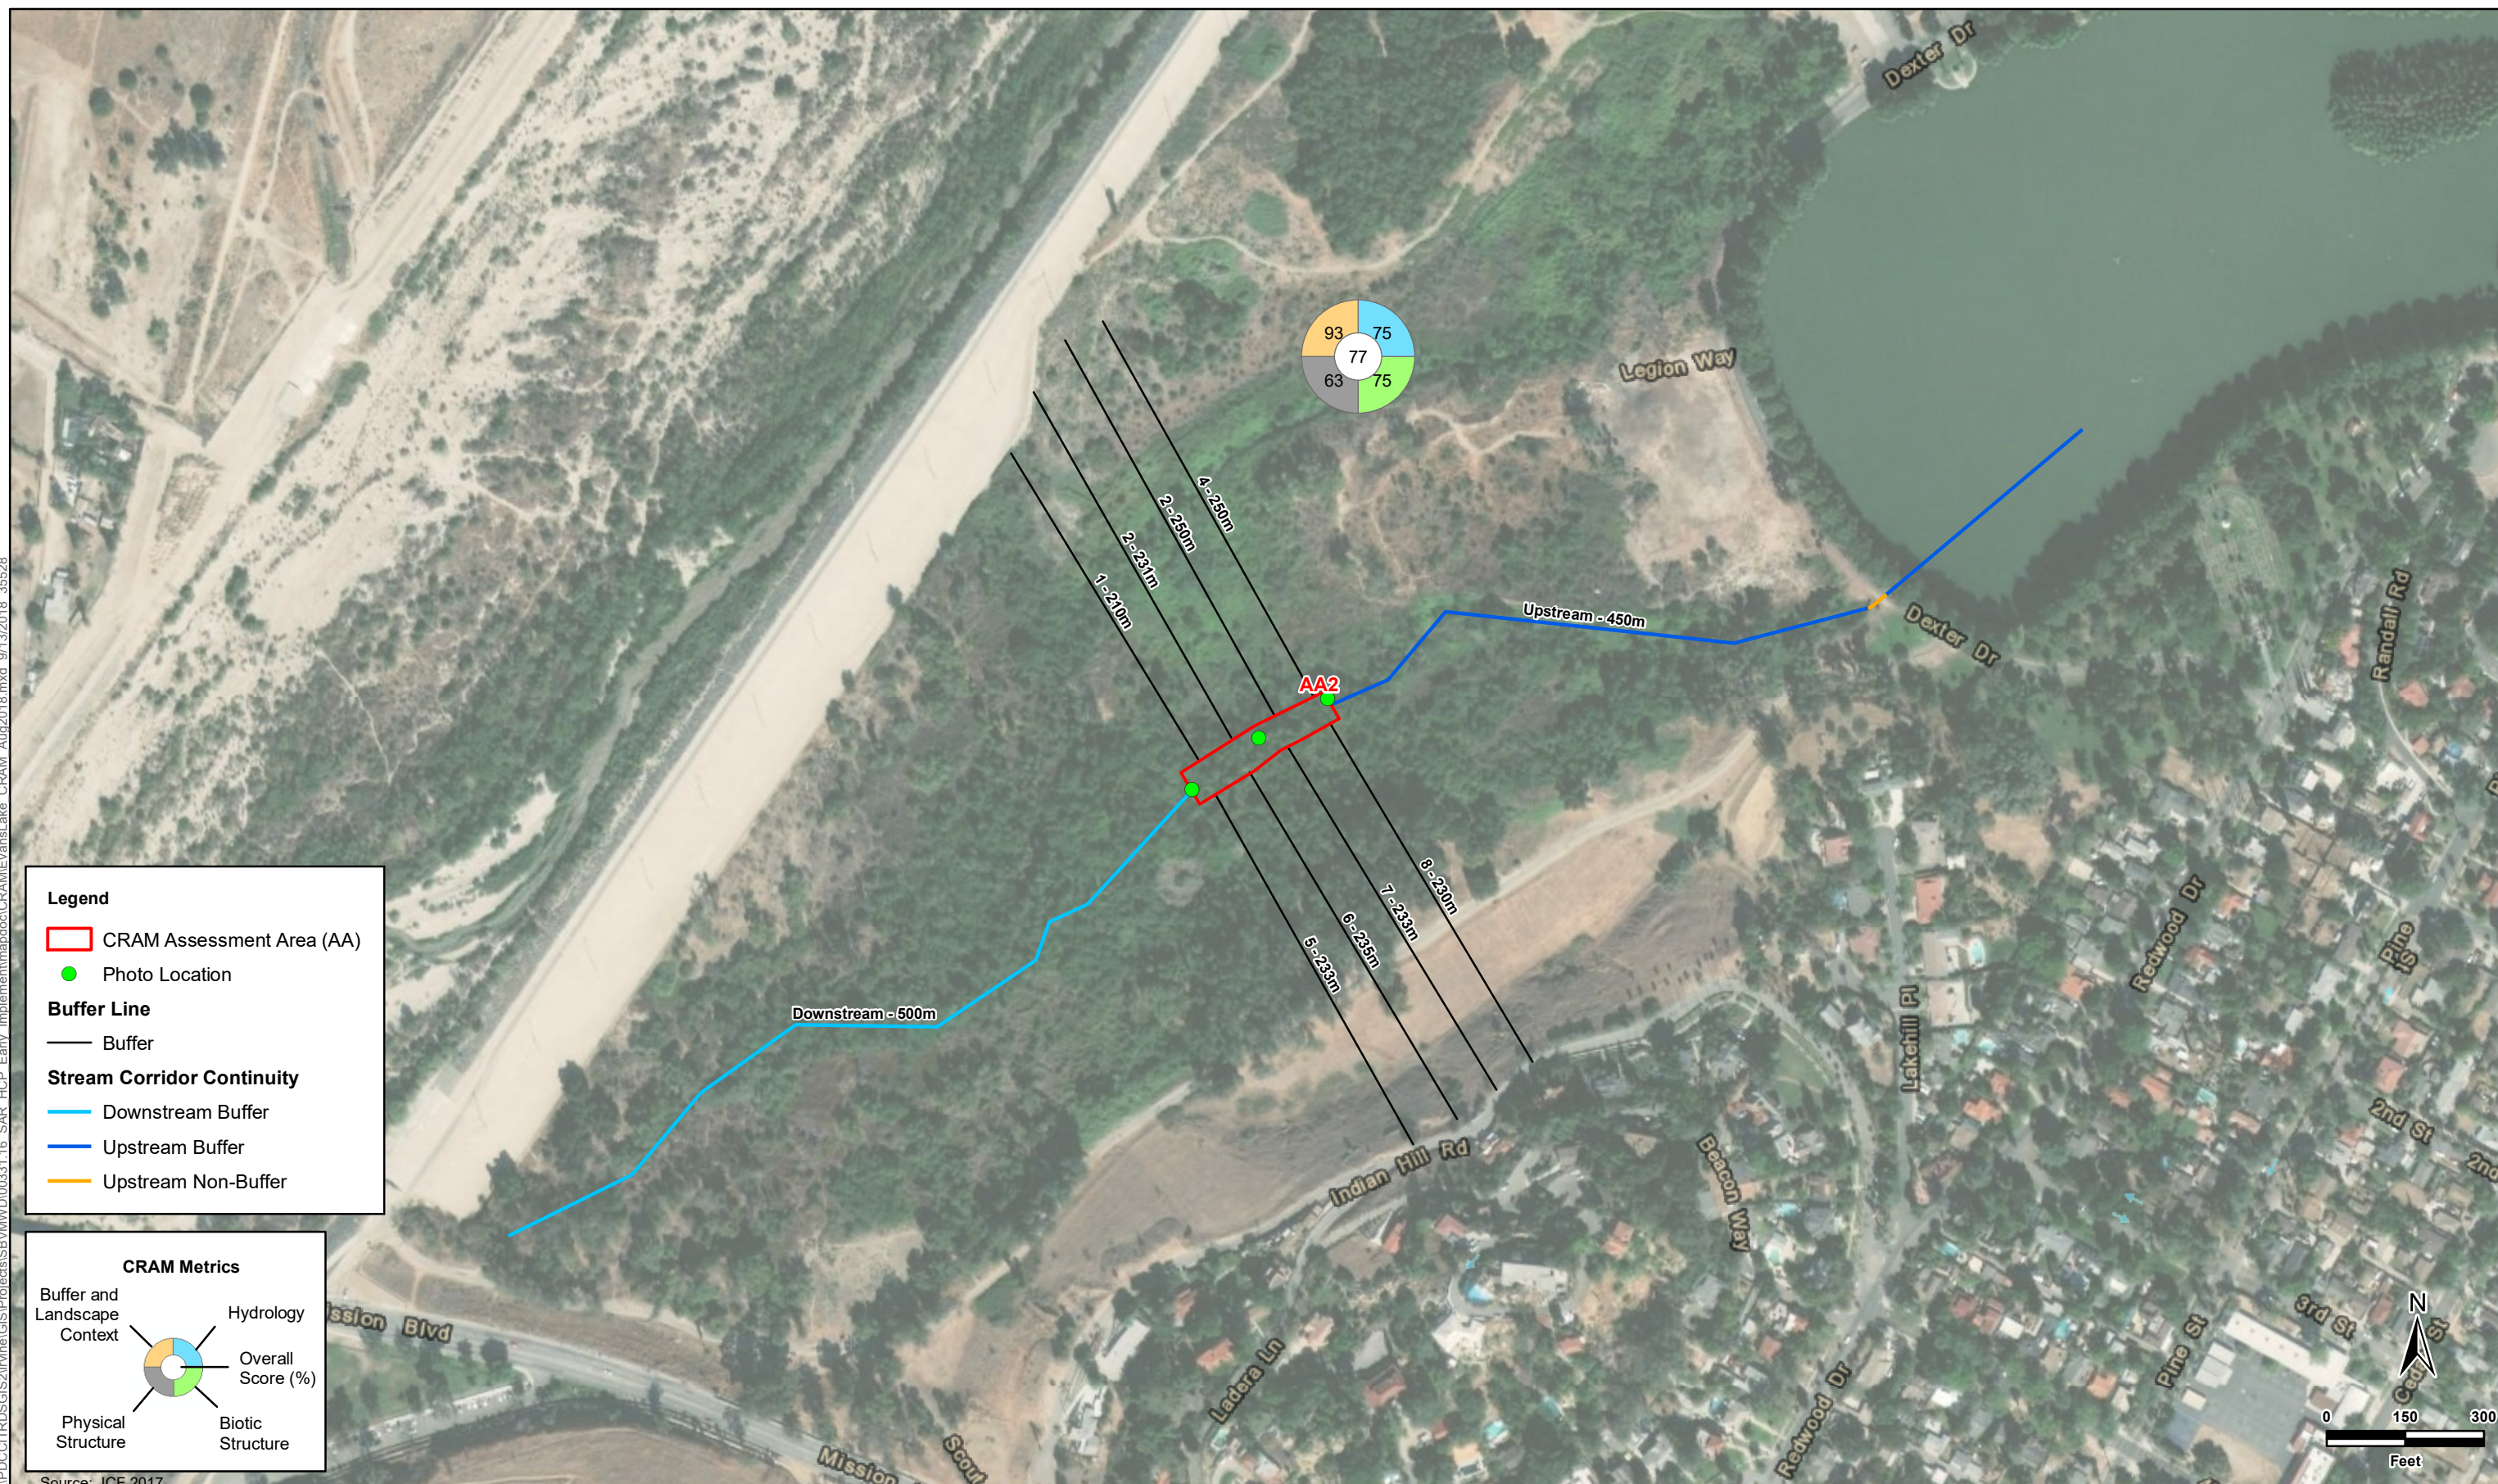
Figure 2-AA2
Evan's Lake CRAM Results
Early Implementation for the Upper Santa Ana River Habitat Conservation Plan

AA2 is located within the southern drainage channel at the project (Figure 2-AA2). The channel receives flows through a culvert from a riser spillway in Evan's Lake. Water was flowing into the channel at the time of the CRAM assessment. The AA received an overall attribute score of 93.3% for the Buffer and Landscape Context attribute. The Stream Corridor Continuity metric received an A with 164 feet (50 meters) of non-buffer segment upstream (Dexter Drive) from the AA and no breaks downstream. The submetric Percent of AA with Buffer received an A with 100% of the AA containing buffer. The average buffer width came to 768 feet (234 meters) and thus received an A. The buffer condition submetric received a B due to light/moderate human impact (homeless encampments) and soil disturbance and approximately 50% non-native vegetation, primarily on the far northern side.

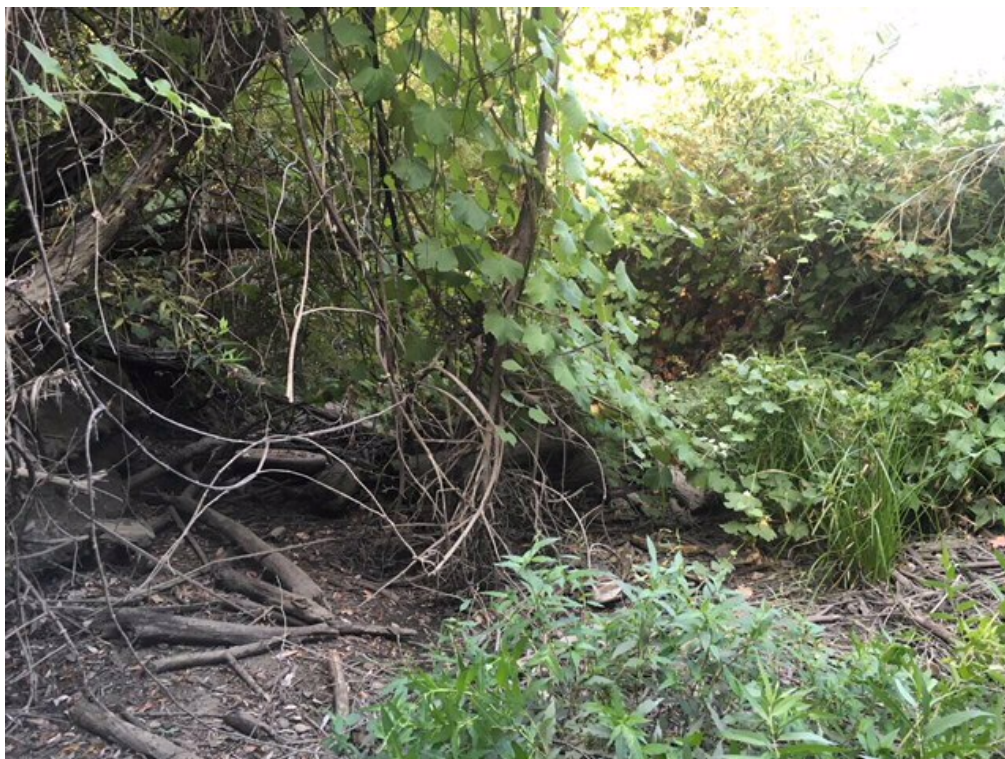
AA1. August 1, 2018. Upstream end of AA looking downstream.

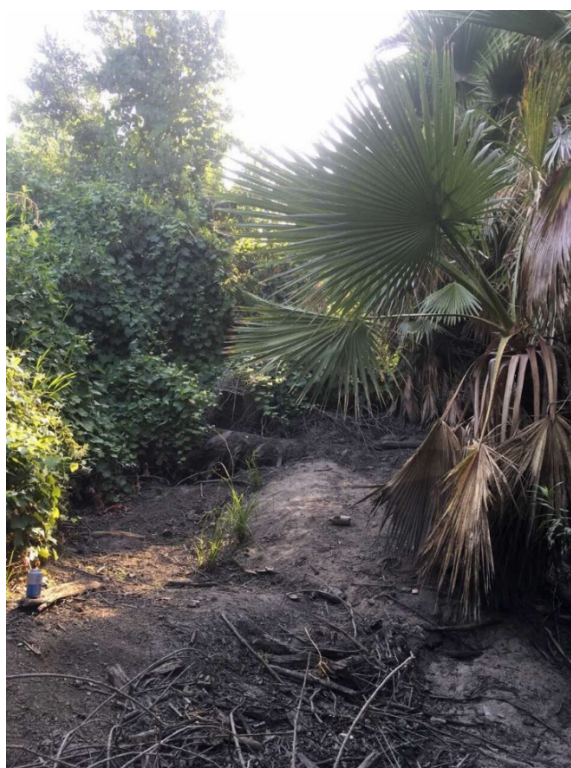
AA1. August 1, 2018. Middle of AA looking upstream.

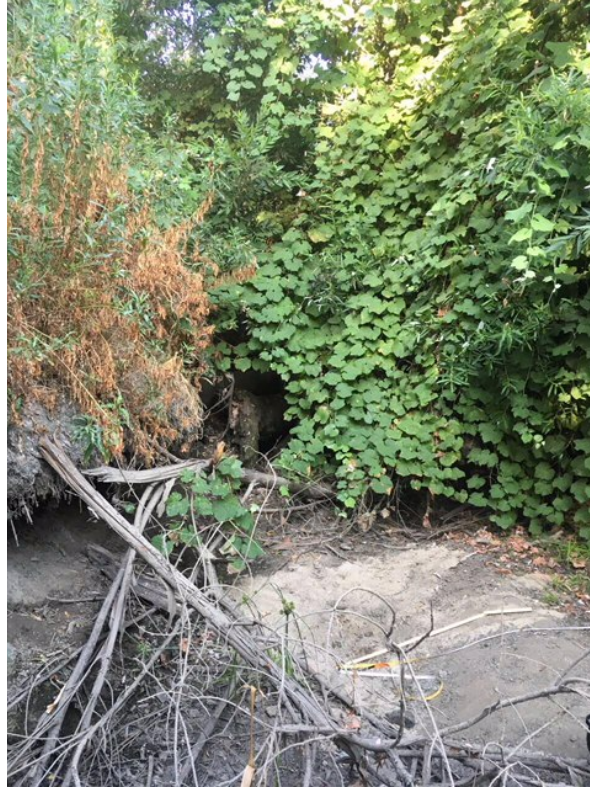
AA1. August 1, 2018. Middle of AA looking downstream.

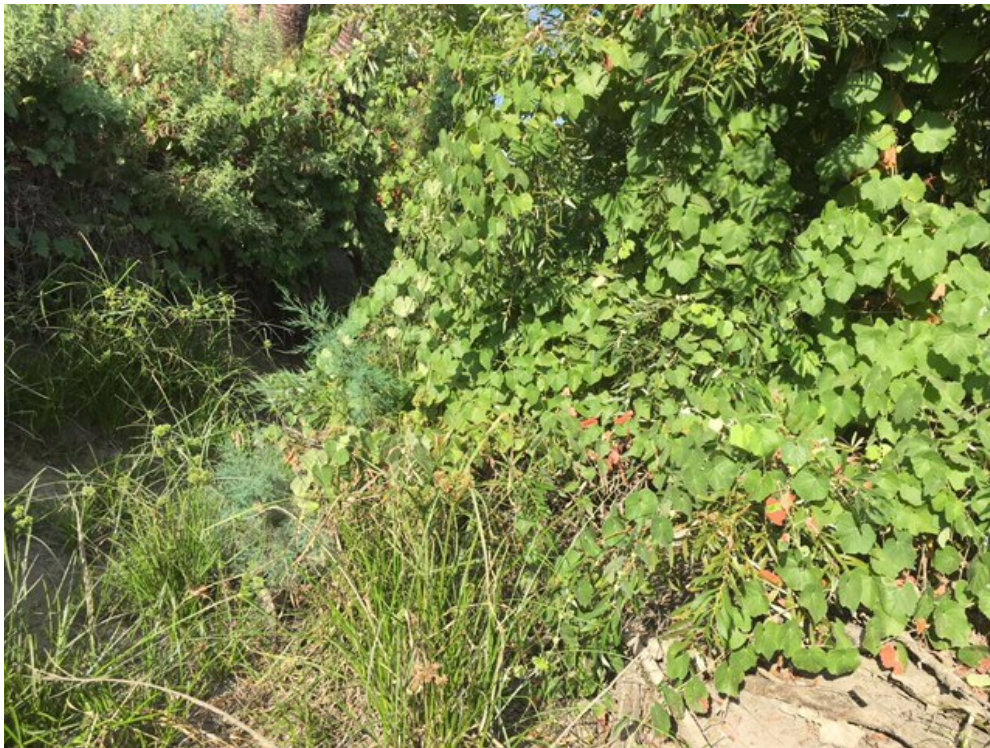
AA1. August 1, 2018. Downstream end of AA looking upstream.

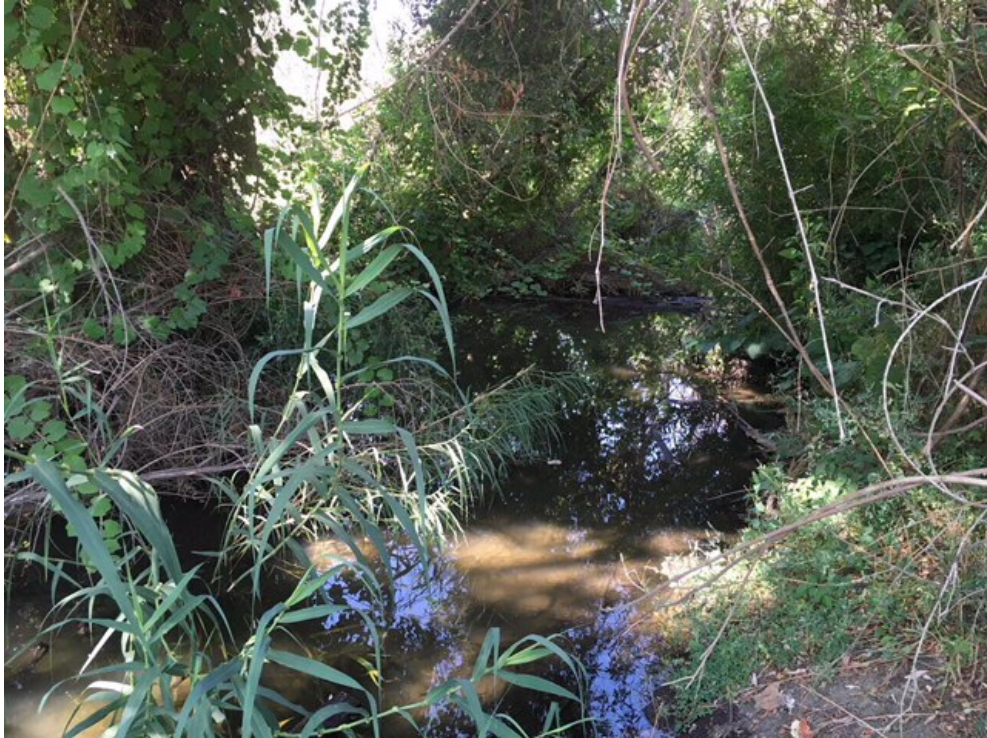
AA2. August 1, 2018. Upstream end of AA looking downstream.

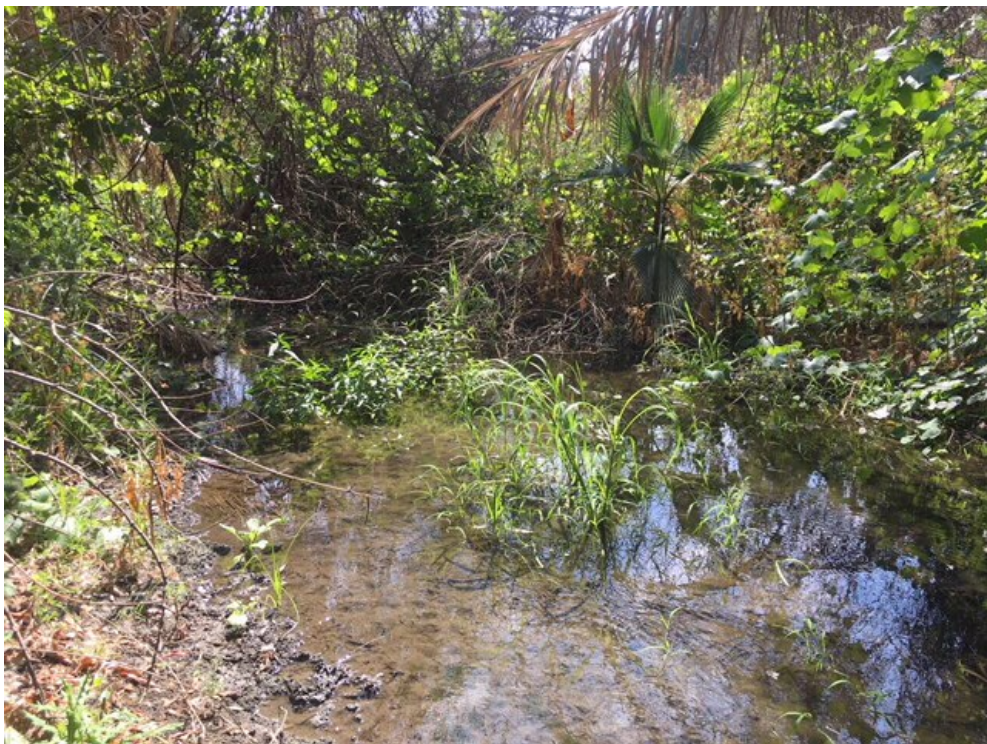
AA2. August 1, 2018. Middle of AA looking upstream.

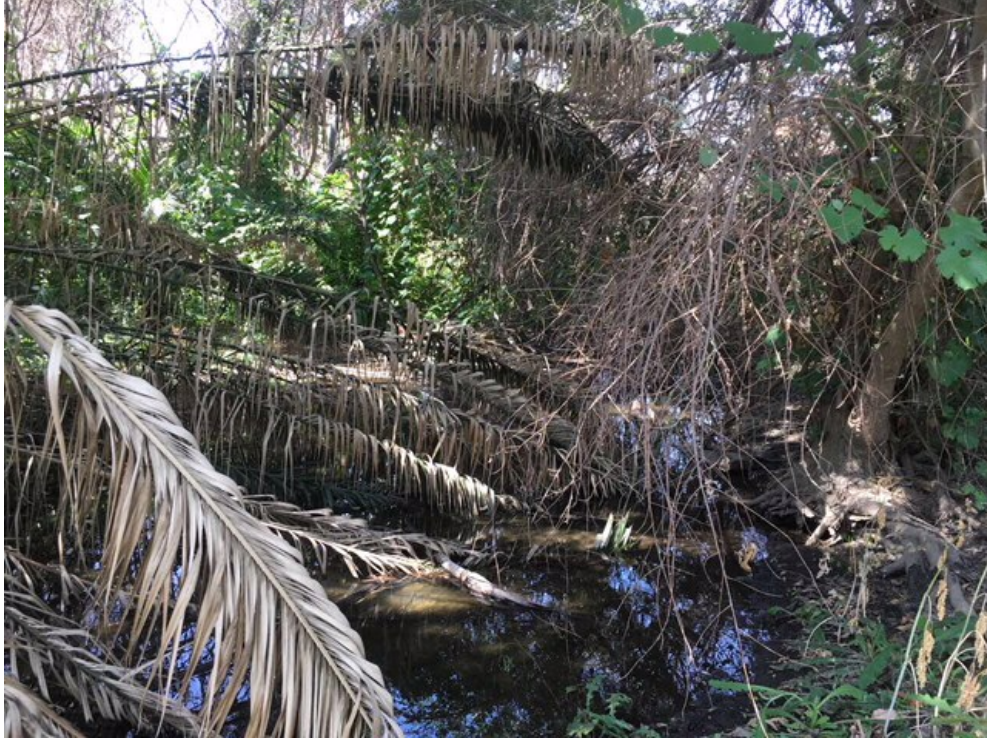
AA2. August 1, 2018. Middle of AA looking downstream.

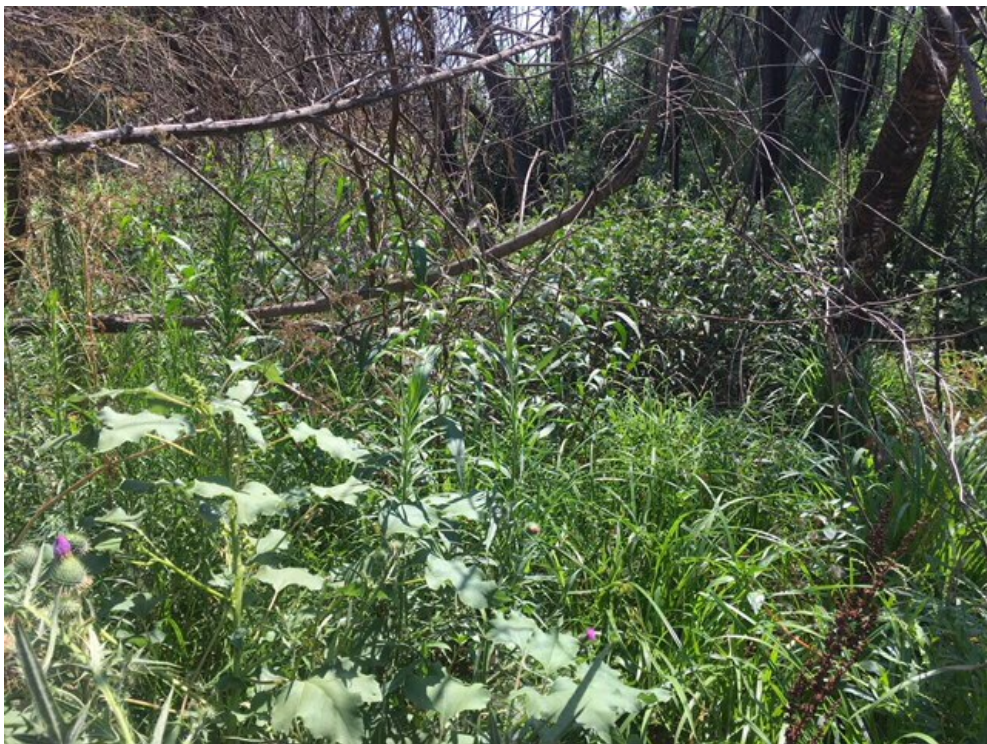
AA2. August 1, 2018. Downstream end of AA looking upstream.

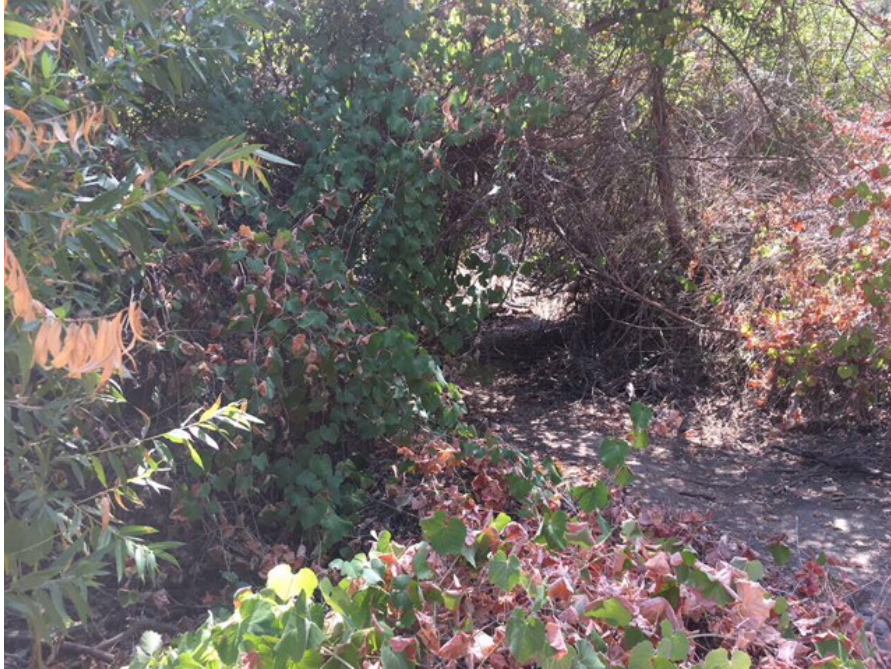
AA3. August 1, 2018. Upstream end of AA looking downstream.

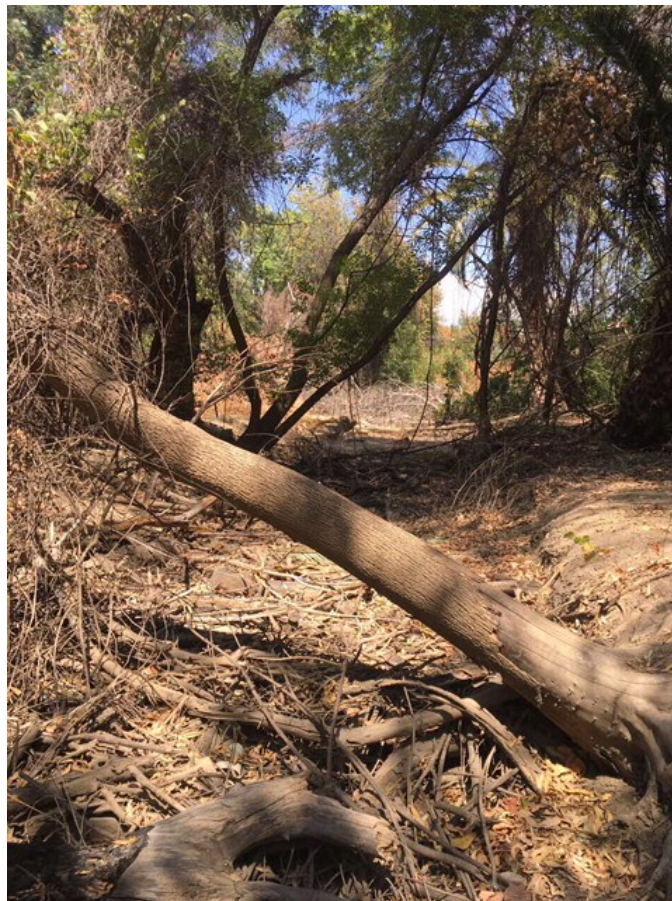
AA3. August 1, 2018. Middle of AA looking downstream.

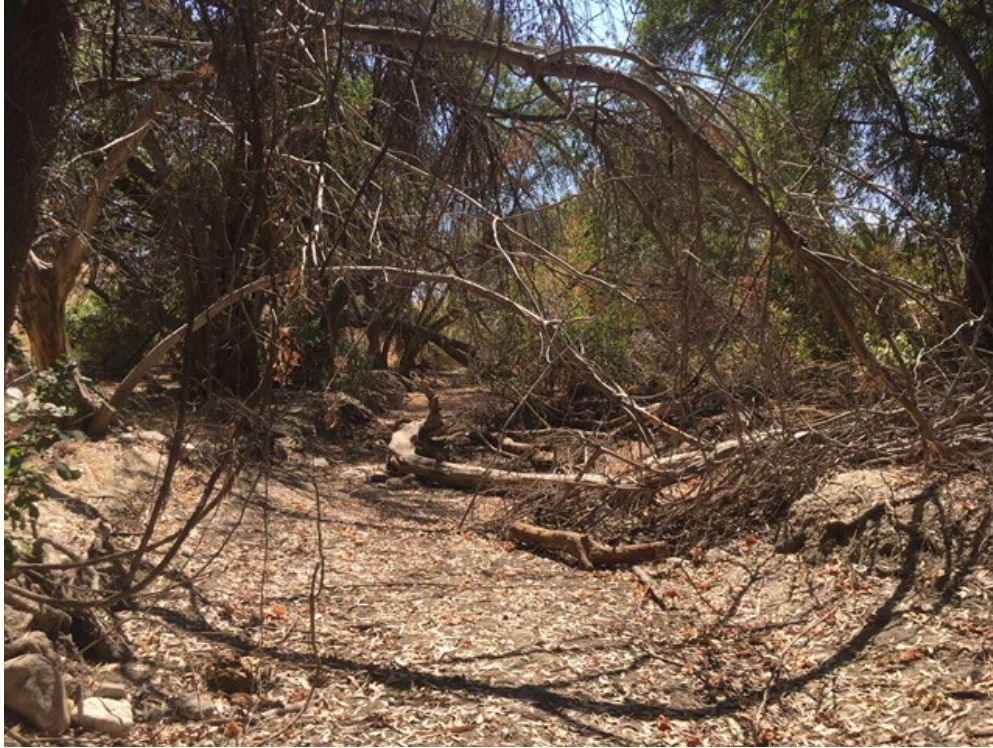
AA3. August 1, 2018. Middle of AA looking upstream.

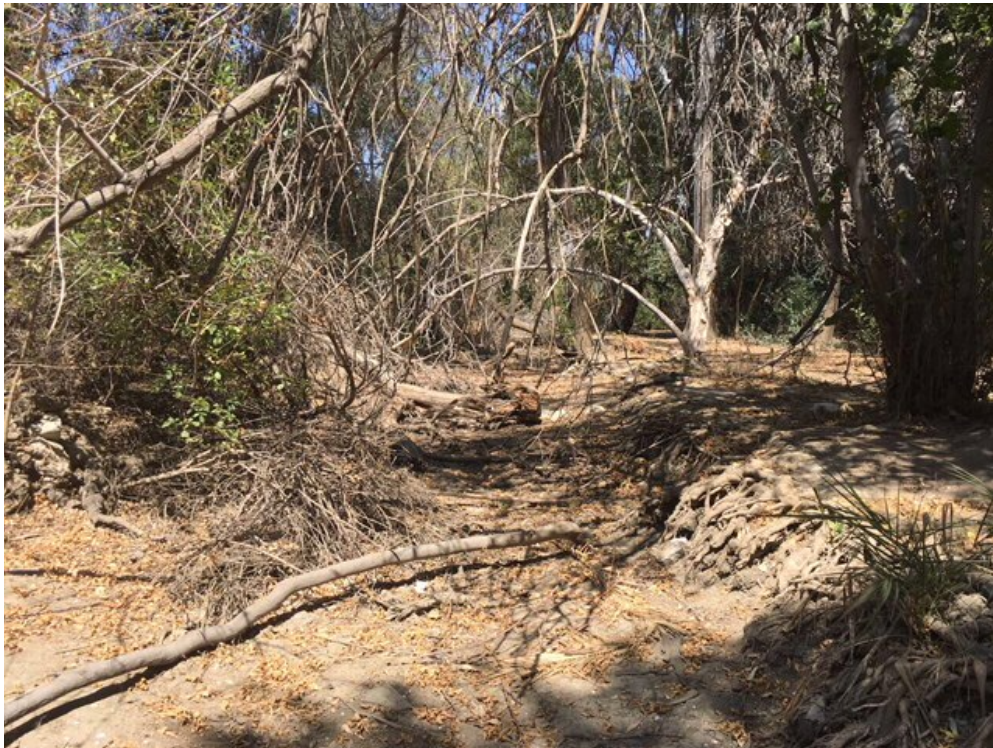
AA3. August 1, 2018. Downstream end of AA looking upstream
